The Submarine Division of the Naval Safety Center Presents:

FLASH

Factual Lines About Submarine Hazards

July - September 2000

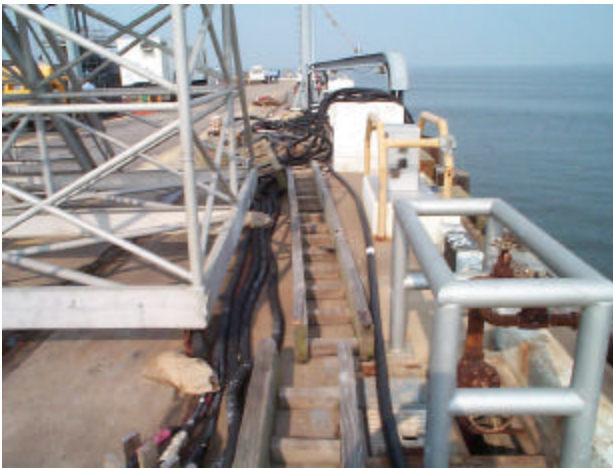
Wood saddles at the center of the picture lay unused. Cables are not protected from damage by the motion of the brow.

The shock was the result of a damaged cable standing in water. Though the Sailor on this mishap was on a surface ship, submarine Sailors are not immune to the hazards posed by

the situations depicted in the pictures above. Both pictures were taken on a submarine pier.

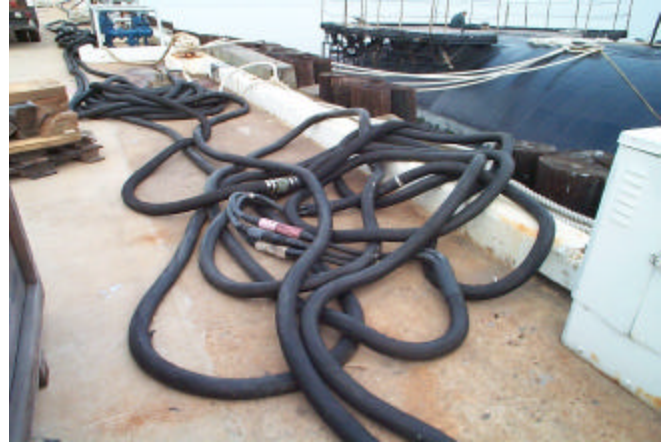
Connectors not raised from the deck. Cables are bent excessively. Again, no wood saddles used.

What are some of the requirements? To keep situations like the mishap related from happening, and to manage the risks associated with shore power cables, they are required to be laid out on wood saddles or wrapped in canvas. You are required to raise connectors and splices from the deck or pier to protect from water contamination. The slack on the cables between the ship and the pier should allow for movement due to the tide, but not enough to allow the cable to dip into the water. Cables need protection against damage by vehicle and pedestrian movement. Moving energized shore power cables is prohibited under most circumstances. Read the complete section on shore power requirements in paragraph 320-2.2.7 of NSTM 320 (Electric Plant General).

These example pictures depict mishaps in the making. A little common sense and a little **Operational Risk Management** can make our piers safer places to work and make travel to and from the boat a non-risky adventure.

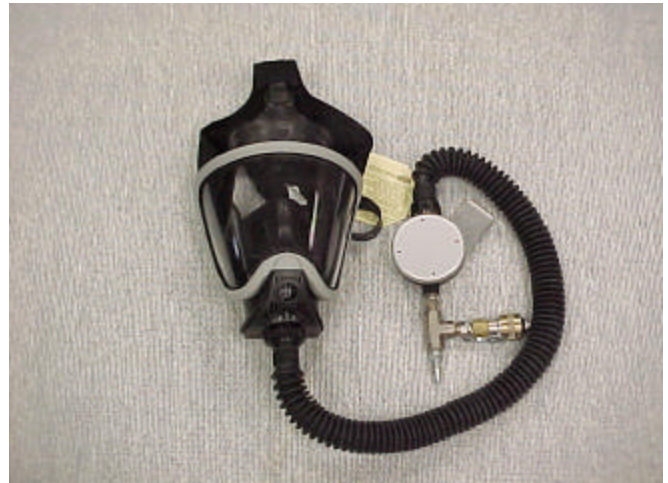
Recently the Mine Safety Appliances (MSA) Company improved the EAB masks that they supply to the Navy. These improvements include a swivel connection in the air tube at the base of the mask, a bigger lens with a wider field of view, a lighter face piece that provides a better face seal, and cloth covered head straps. If you are using a sound powered phone, the speaking diaphragm is still above the breathing tube but you can't see it because it is recessed into the nosecup assembly. The down side is that the existing audio projection units (APUs) can not be used with the new EAB masks. New APUs must be open purchased through MSA using GSA contract number GS-

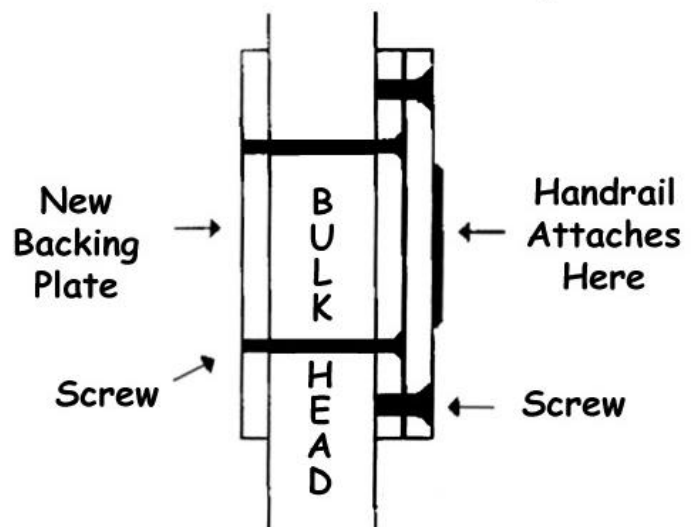
FCUL-FCML Ladder Way

An enterprising MM1 on the USS Bremerton (SSN-698) came up with this low cost solution. This drawing depicts the repair of the ladder way, lower handrail attachment point, (the MM1 developed) that is attached to

the hollow bulkhead in middle level. A new 1/8" x 2" stainless steel backing plate (manufactured by the IMA) is attached with four 1/4" x 20 mild steel screws to the bulkhead. Mild steel screws are used to eliminate the possibility of galling.

During the time you spend on your submarine, the handrail on the ladder from upper-level to middle-level will come loose numerous times. This appears to be a 688-class problem. The basics of the problem are that the rivets used to attach the original handrail backing plate to the bulkhead pull out.

The normal remedy is to enlarge the holes and use larger rivets, but these eventually pull out also. Now many wasted man-hours will have been wasted to do some fix that will just fail in time. Now here is a permanent fix that won't pull out and that affords removal of the handrail if the situation requires.

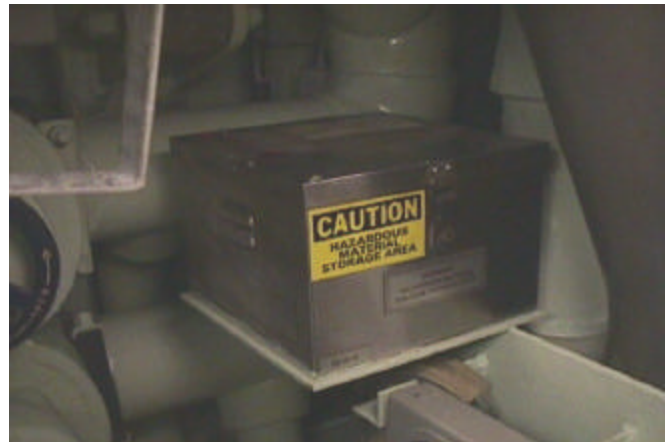
This calcium hypochlorite locker is installed in the athwartship passageway above the charging connection.

The problem I've seen during safety surveys on boats that have their HTH stowage in the capstan space is that there is frequently a bunch of other stuff being stowed there with the HTH locker. The other stuff ranges from mooring lines to man-overboard bags to life preservers, etc. Most of the time this gear is thrown in the capstan space on top of the HTH locker. These other **things** stowed in the capstan space range from oil and/or water contaminated and could be combustible material. This makes the capstan space a less than ideal location for your HTH locker. The ideal location is in the athwartship passageway where SSNs 751 and above have it installed. I spoke with NAVSEA and Newport News
